In reply refer to:
P-405-MD
NATDAM #MD00097
Conowingo Project

Subject: 2024 Dam Safety Inspection Follow-up

2024 Dam Safety Inspection

FERC Project No. 405-MD

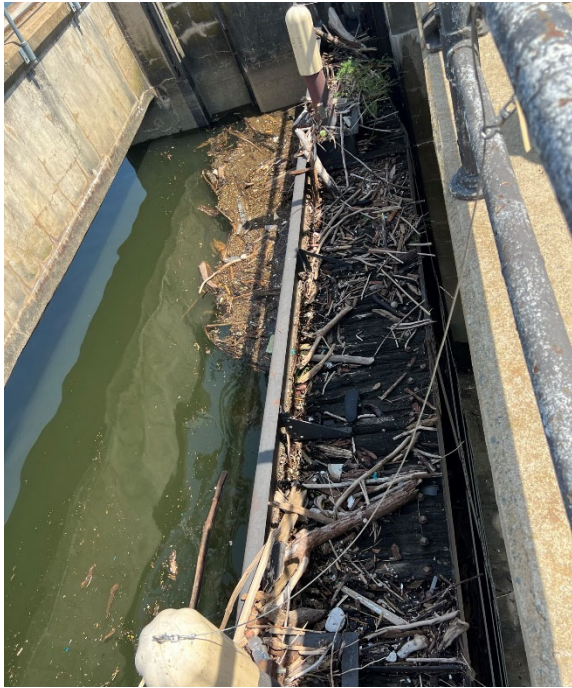
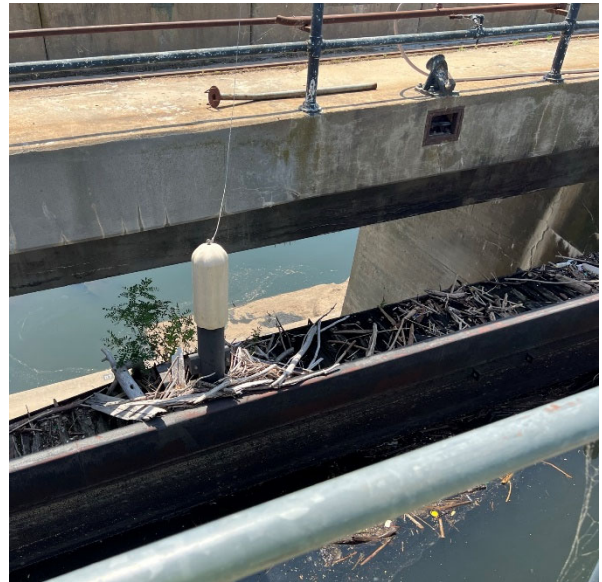
Photo 1 – Deposit of debris and vegetation in the spillway gate structures (found in most of them)

1. Deposit of debris and vegetation were found on most of the spillway gate structures (Photo 1). Please clear all debris and vegetation from the gates prior to the next inspection and implement a routine maintenance program for the same.
2. Seepage in the confined space behind Units 8 to 11 that was noted during the 2023 inspection continues to occur, but it is now being collected and pumped into a drain (Photo 2). We understand that a dye-test investigation is being planned to assess the source of the seepage as per our 2023 inspection recommendations. Please submit the results of dye test when it is available.

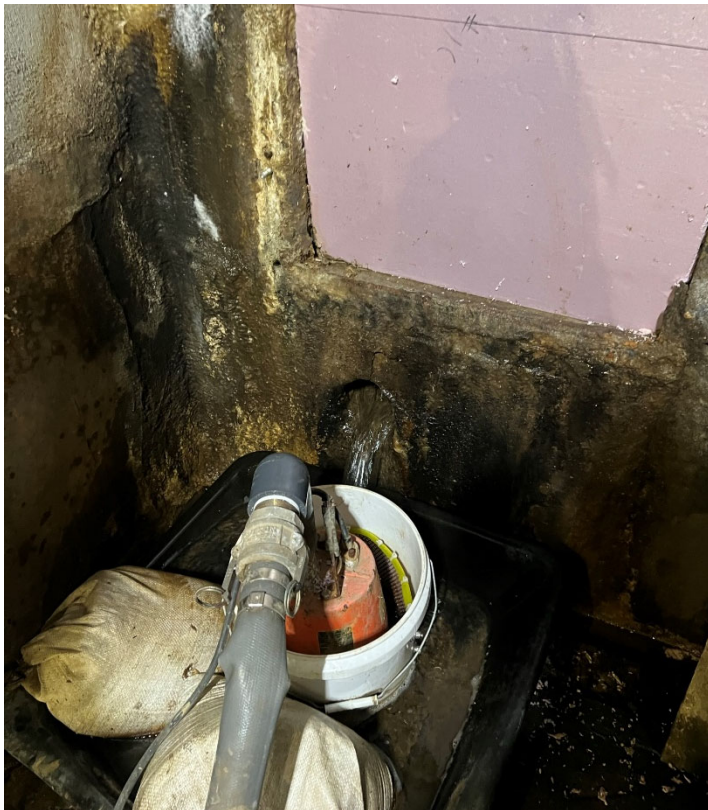
Photo 2 – Seepage in the confined space behind Units 8 to 11 being collected and pumped into a drain
