FEDERAL ENERGY REGULATORY COMMISSION
Office of Energy Projects
Division of Dam Safety and Inspections – New York Regional Office
Telephone No. (212) 273-5900

RE: Letter to Constellation Energy Generation regarding the 2025 Inspection of the Conowingo Project under P-405

P-405-MD, Conowingo
2025 Dam Safety Inspection

2025 Dam Safety Inspection
FERC Project No. P-405-MD

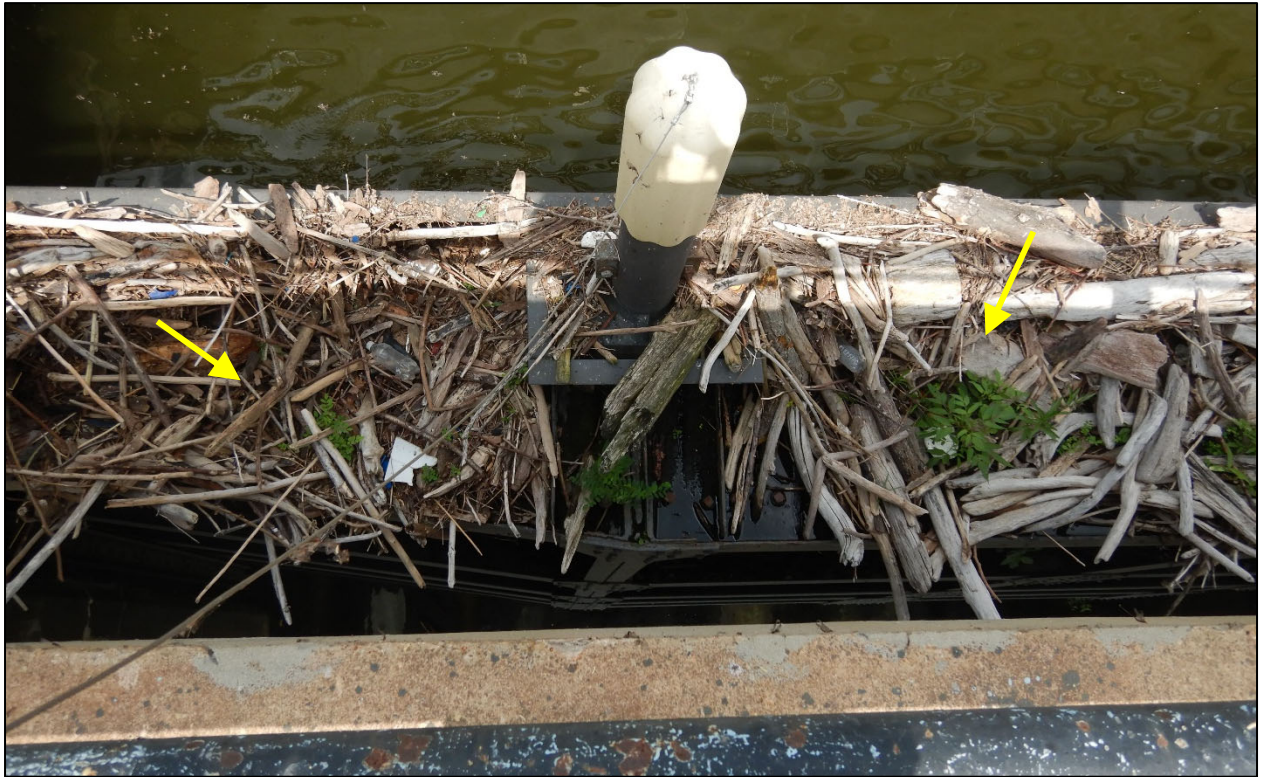
1. Deposit of debris and vegetation were found on a few of the spillway gate structures (Photo 1). Please clear all debris and vegetation from the gates prior to the next inspection and implement a routine maintenance program for the same.

Photo 1 – Deposit of debris and vegetation on a few of the Spillway gates

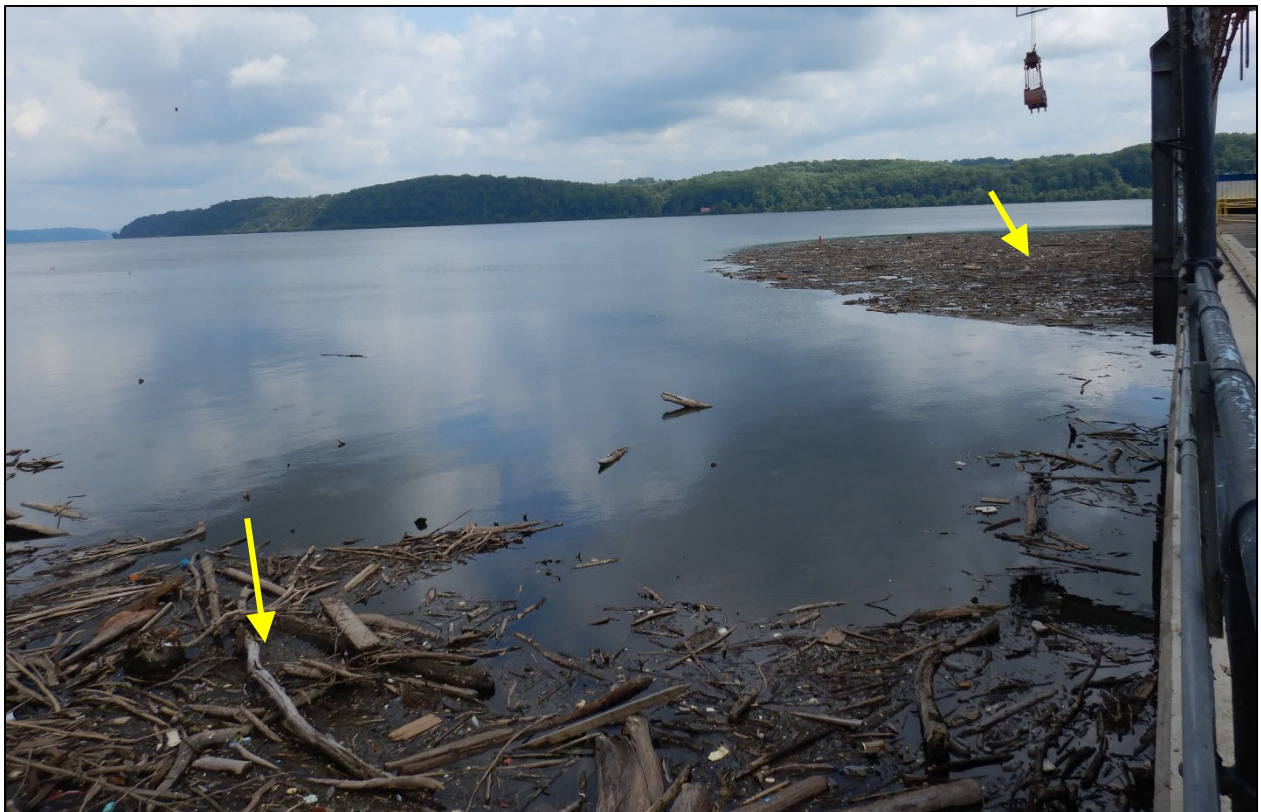
2. Accumulation of debris was found on the upstream side of the Powerhouse Intakes and the Spillway gates (Photo 2). The debris poses a risk as they may cause issues for the gate operations and/or reduce the discharge capacity if clogged. Please monitor and clear the debris and implement a routine removal program.

Photo 2 – Debris on the upstream side of the Powerhouse Intakes and the Spillway gates

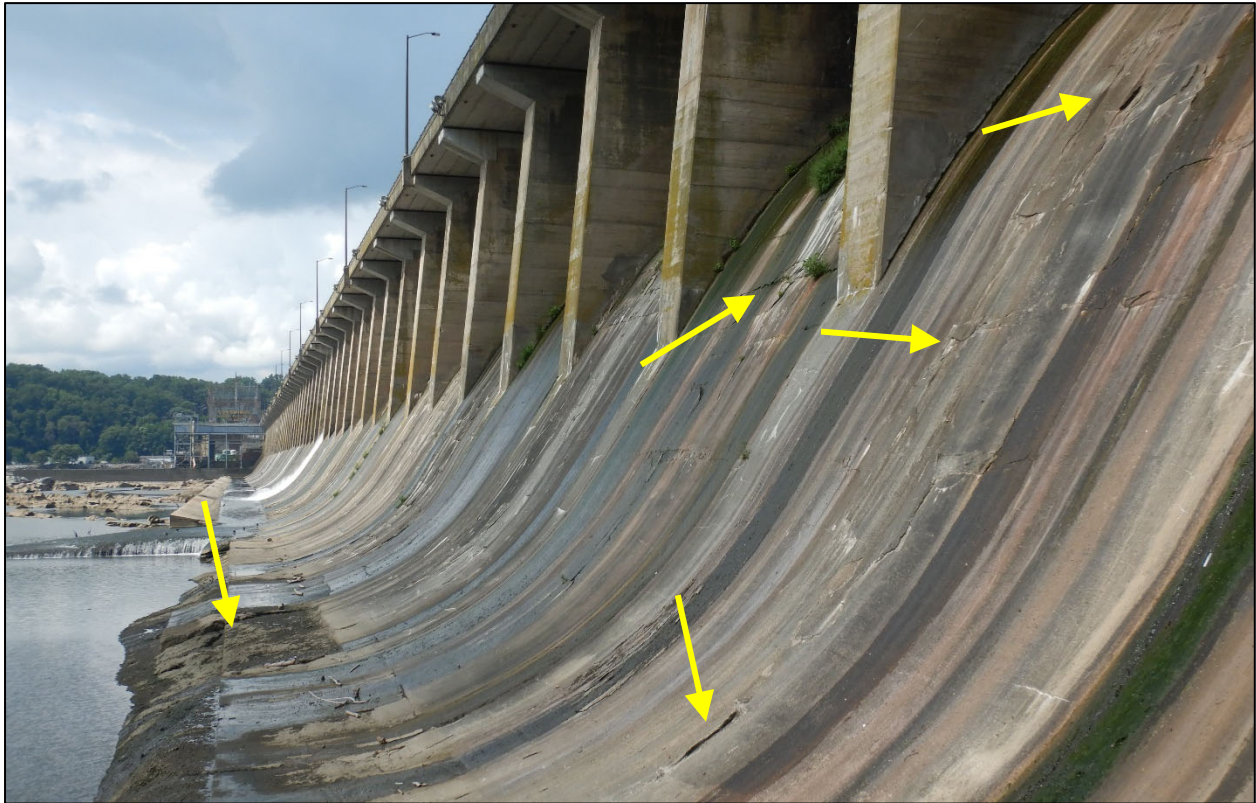
3. Concrete deteriorations have been observed on the downstream face and the toe of the Spillway bays (Photos 3 and 4) and the Left Non-Overflow section (Photo 5). Please continue to monitor and assess their conditions and include/prioritize the repairs as needed in your ongoing Concrete Asset Management Program (CAMP).

Photo 3 – Concrete deteriorations on the downstream face and the toe of the Spillway bays

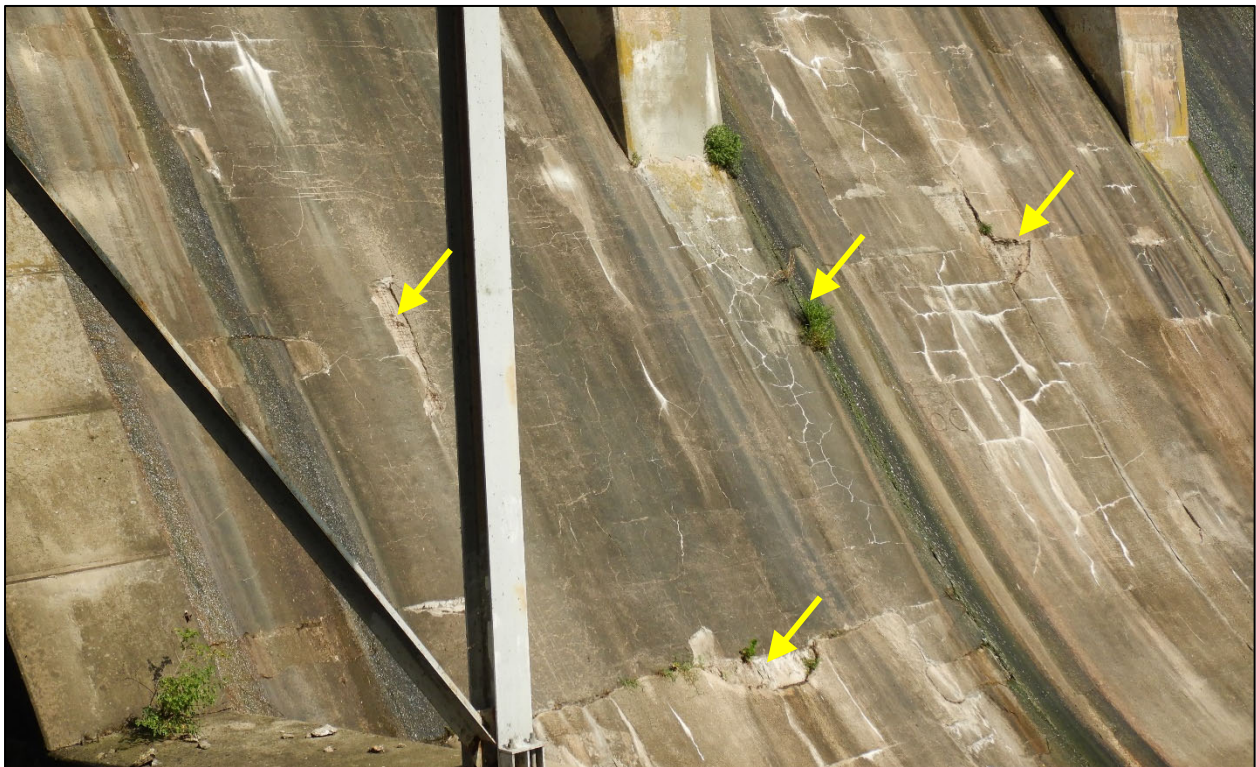
Photo 4 – Concrete deteriorations on the downstream face and the toe of the Spillway bays

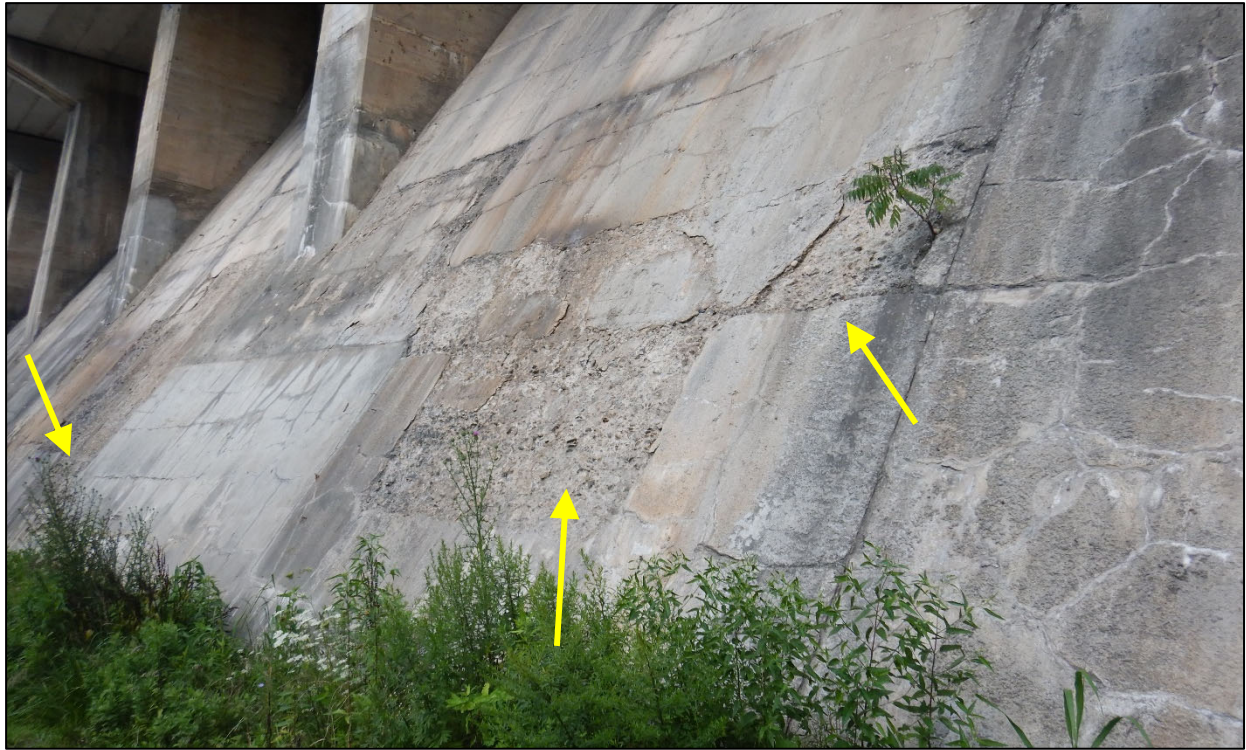
Photo 5 – Concrete deteriorations on the downstream face of the Left Non-Overflow section

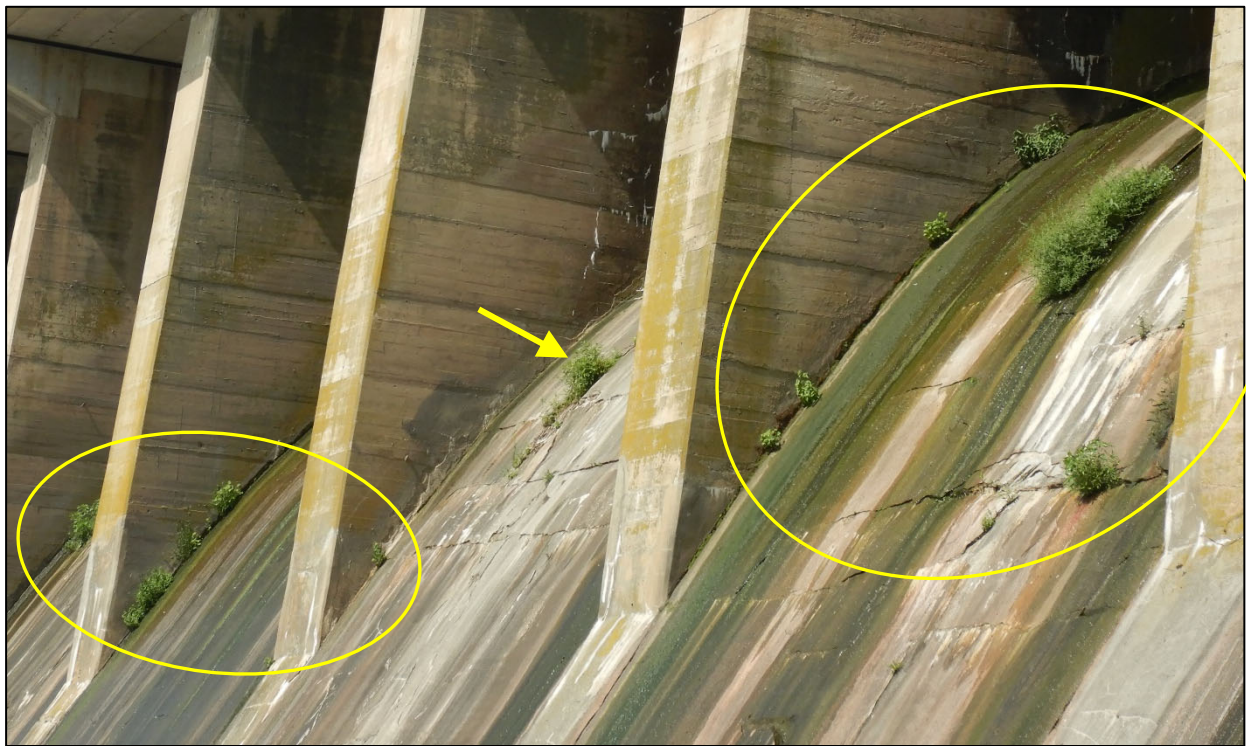
4. Minor vegetation growing from the cracks/ deteriorations on the downstream face of the Spillway bays was noted during the inspection (Photo 6). Please continue to implement the routine vegetation control program for all the project structures.

Photo 6 – Vegetation growing from the cracks / deteriorations on the downstream face of the Spillway bays

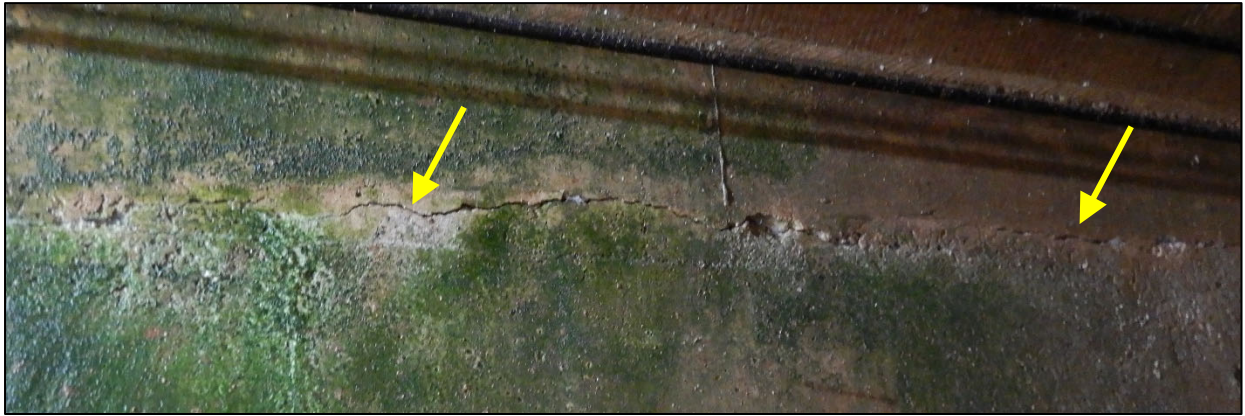
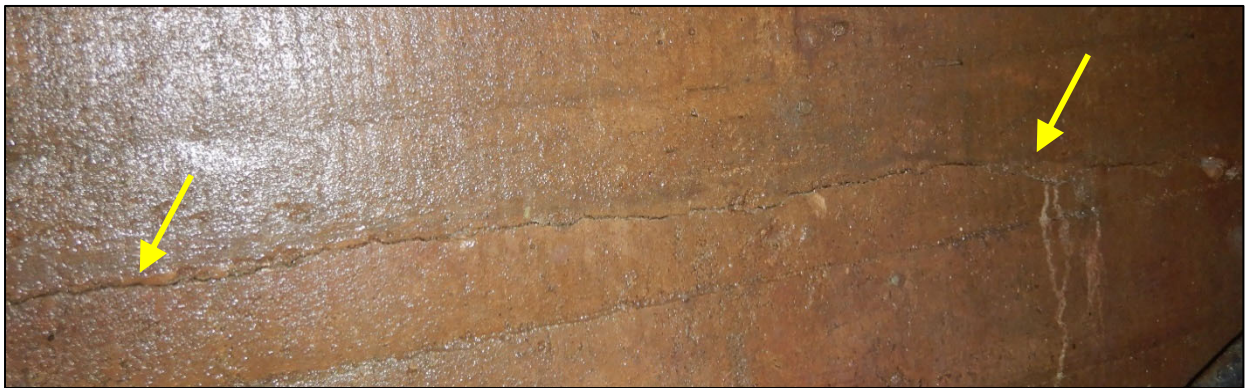
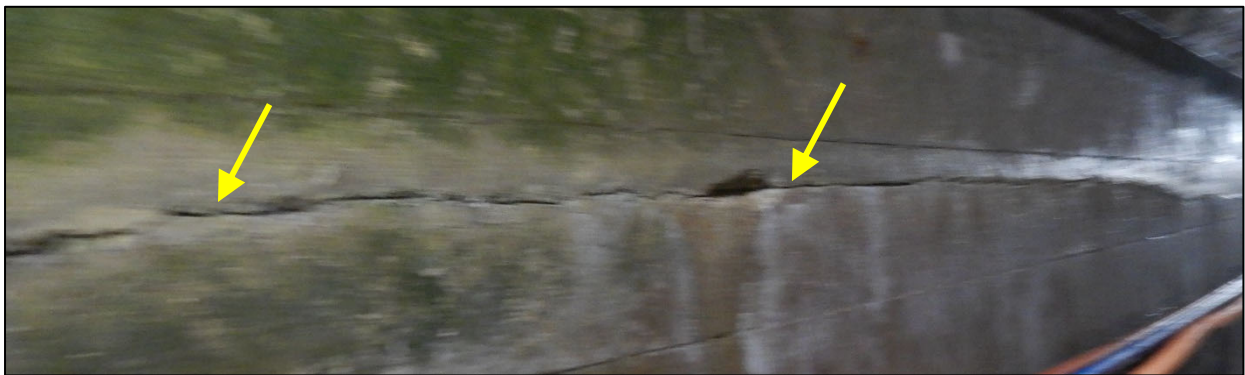
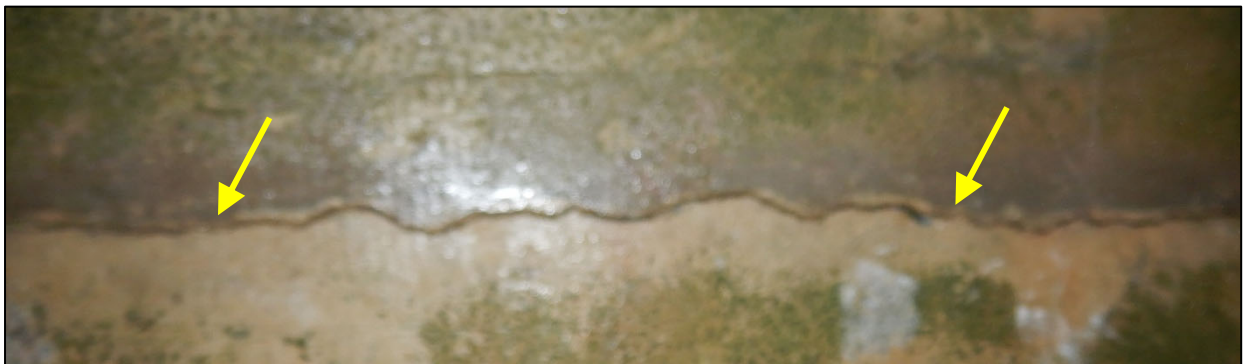
5. There are existing cracks on the downstream and upstream walls of the inspection gallery that runs through the Spillway and the Non-Overflow Sections (Photo 7). Given that it has been proposed to drill and install piezometers in the gallery in near future, we recommend installing crack gages and collecting adequate baseline readings prior to the drilling activities to monitor and ensure that there are no adverse impacts to the cracks from the drilling work. Also please continue to monitor the cracks and ensure that they are not developing further.

Photo 7 – Cracks on the downstream and upstream walls of the inspection gallery

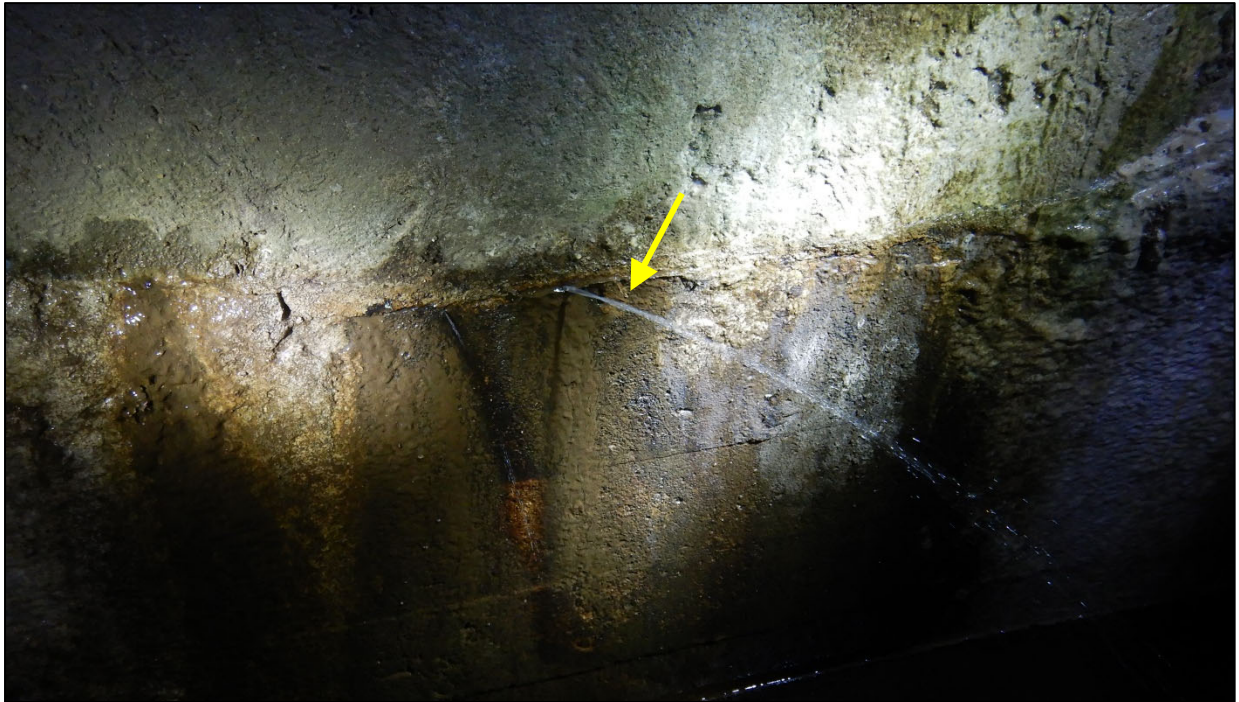
6. A leakage from the upstream wall of the inspection gallery, in the vicinity of Crest Gate 21, was noted during the inspection (Photo 8). Please continue to monitor the leakage and ensure that it is not developing further. Consider repair measure(s), depending on the findings of the monitoring, if deemed appropriate.

Photo 8 – Leakage from the upstream wall of the inspection gallery in the vicinity of Crest Gate 21

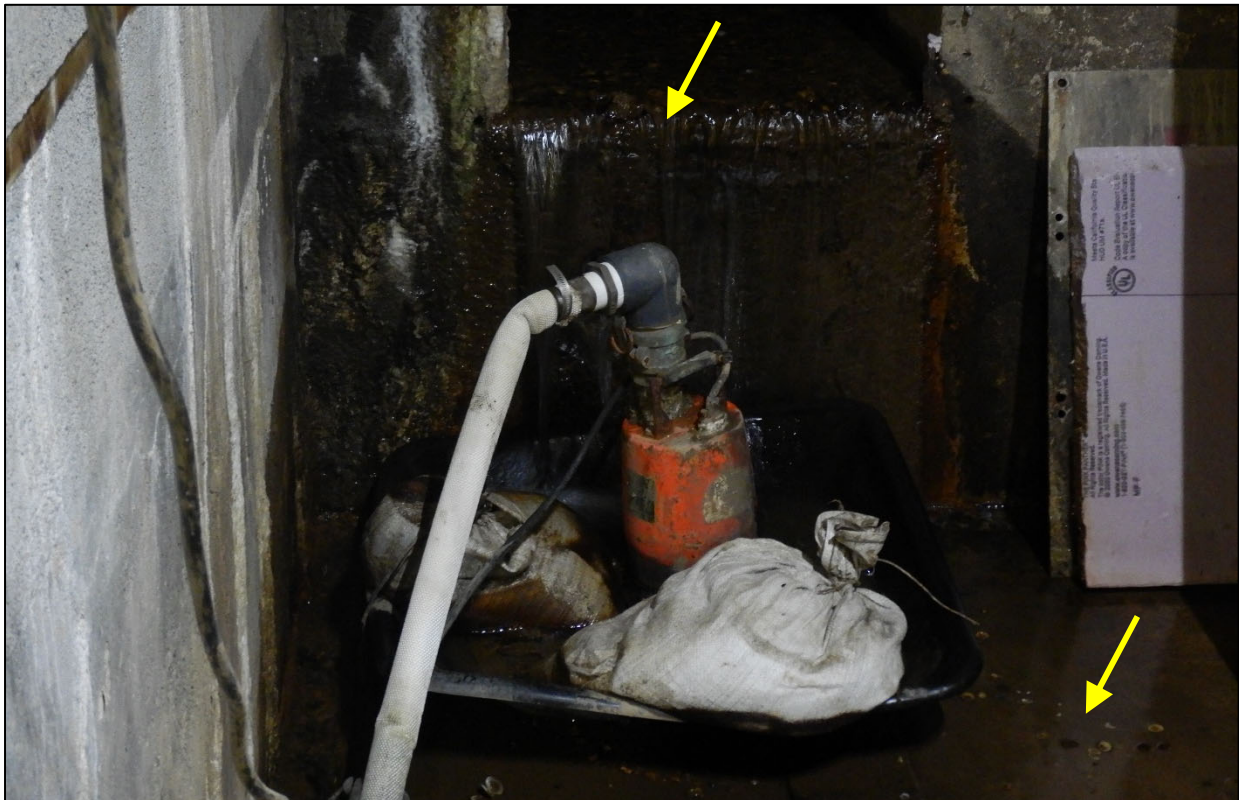
7. Seepage in the confined space behind Units 8 to 11 that was noted during the 2023 and 2024 inspections continues to occur (Photo 9). During the 2024 inspection, it was found to be in a relatively more controlled fashion where it was being collected and pumped into a drain with no excess/ponded water, however the area was found slightly flooded during the 2025 inspection. The cause of the excess water might be increased seepage or any reduction in the pumping efficiency. As such, we recommend investigating this condition further and monitoring the seepage quantity with an appropriate means and method. We understand that a dye-test investigation is being planned to assess the source of the seepage as per our 2023 inspection recommendations. Please submit the results of dye test when it is available.

Photo 9 – Seepage with ponded water in the confined space behind Units 8 to 11 (it is being collected and pumped into a drain, but the floor is slightly ponded)

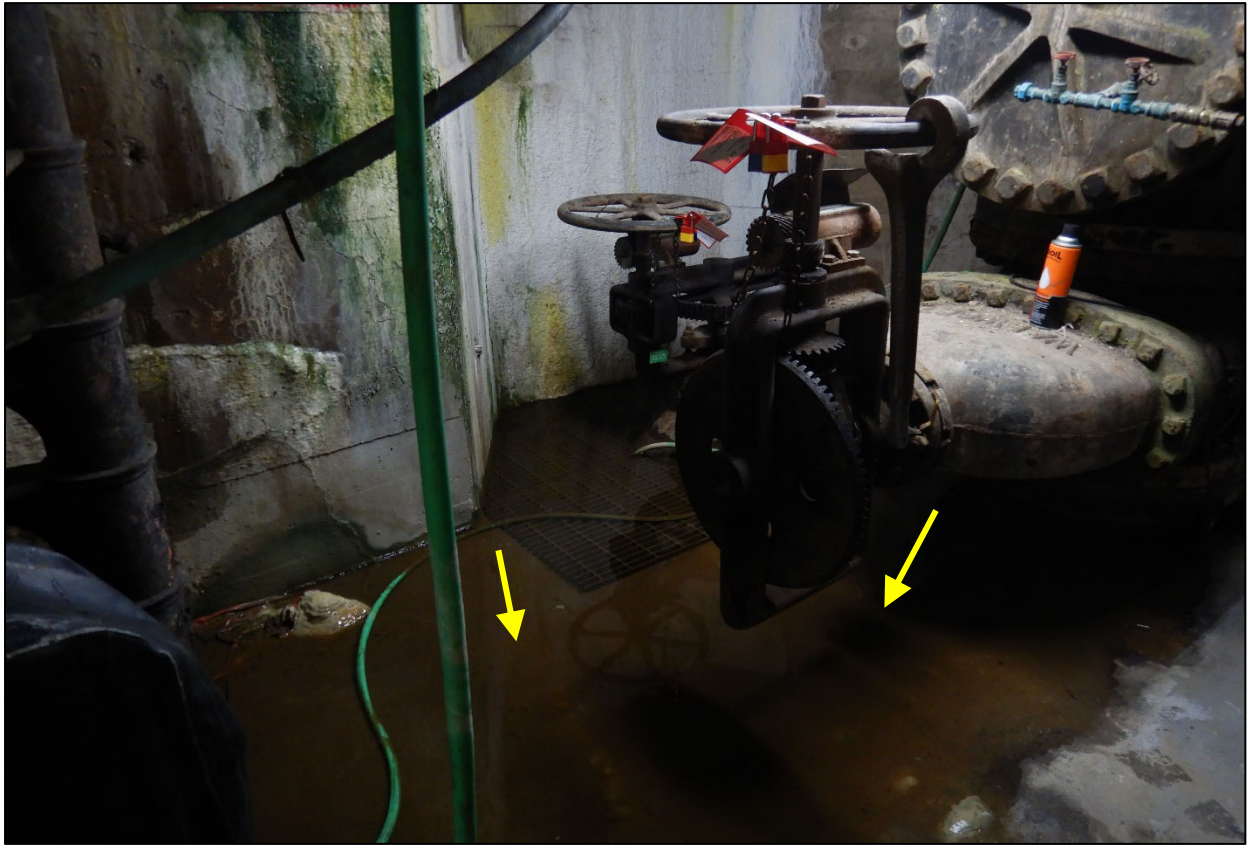
8. Ponded water was noted on the floor of the Elevation 65 powerhouse inspection tunnel, in the vicinity of Units 2 and 4 controls (Photos 10 and 11). Please investigate the cause of these conditions and remediate the leakage/flooding. In the meantime, please continue to monitor the areas and ensure that it is not developing further.

Photo 10 – Ponded water by the Unit 4 controls in the powerhouse inspection tunnel

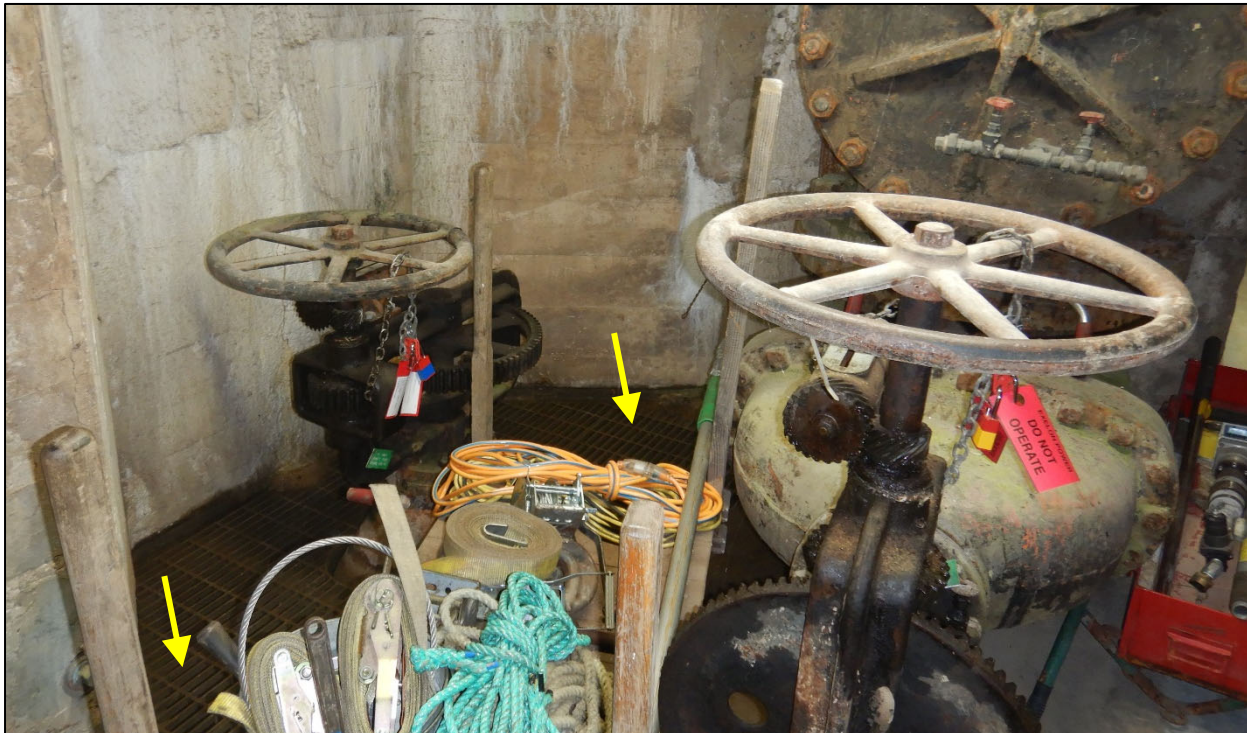
Photo 11 – Ponded water by the Unit 2 controls in the powerhouse inspection tunnel
